Re: San Jacinto River Waste Pits Superfund Site

IMPACT OF DREDGING ON THE SAN JACINTO RIVER WASTE PITS TIME CRITICAL REMOVAL ACTION SITE

December 2011

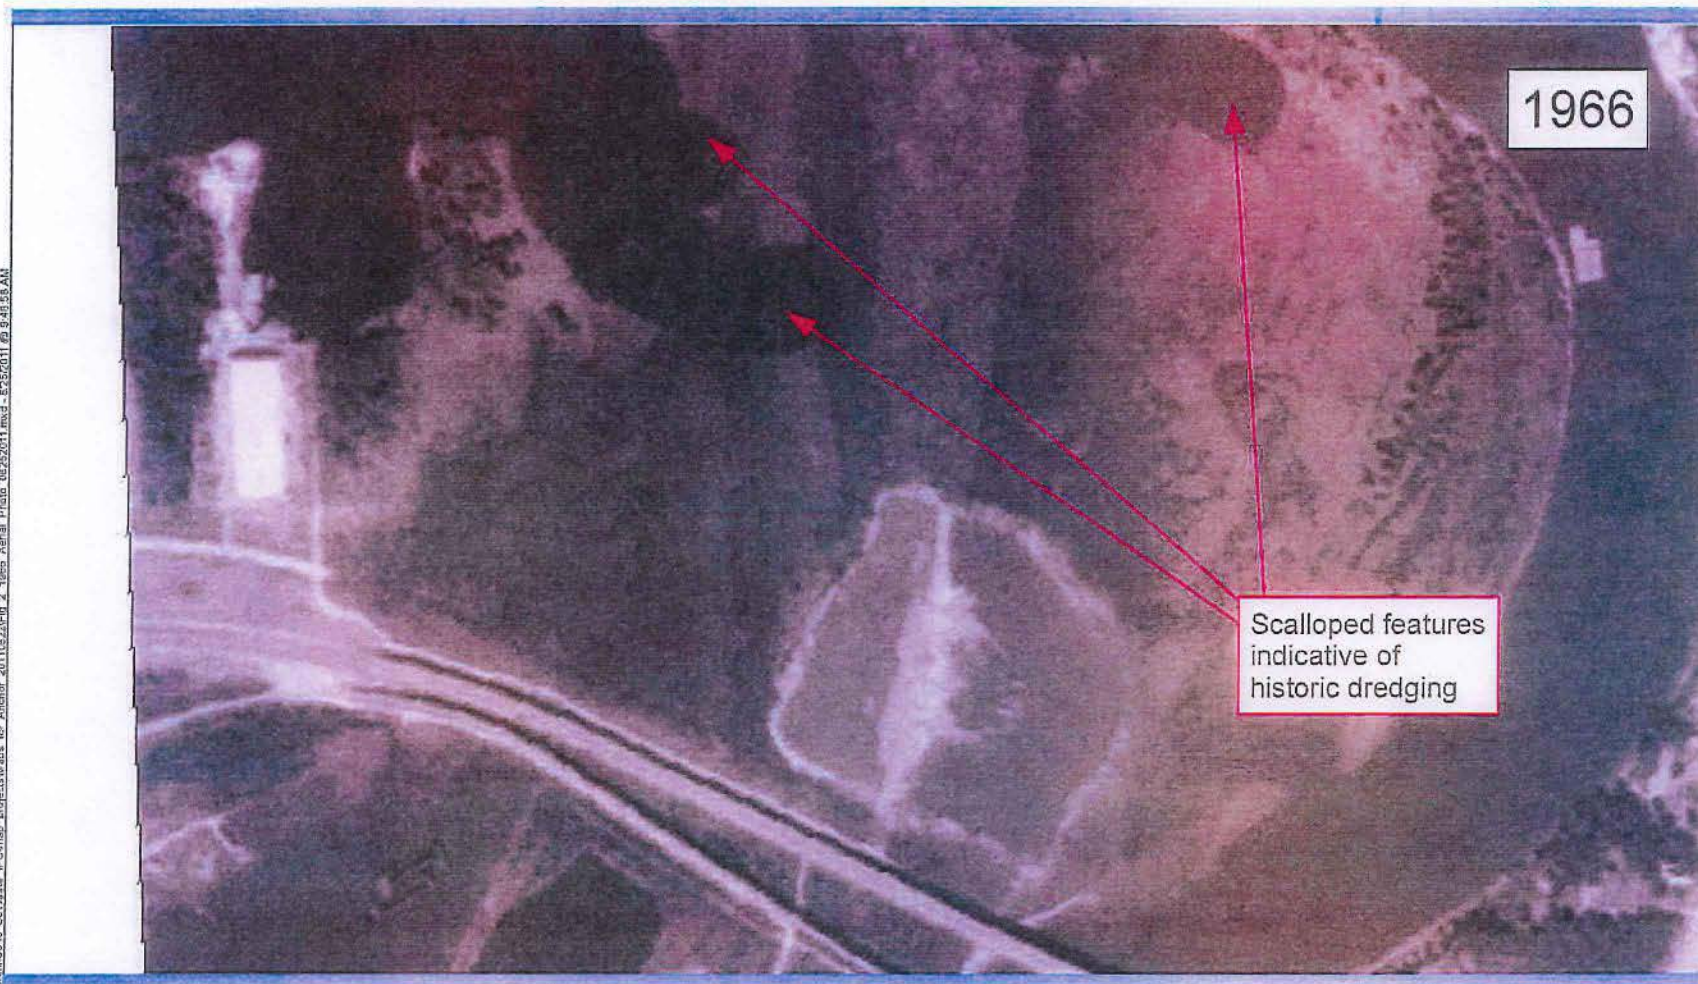
Figure 2
1966 Aerial Photo
Impact of Dredging on the San Jacinto Waste Pits TCRA Site
SJRWSP Superfund/MIMC and IPC

- On Figure 2 (1966 conditions), the integrity of the berms surrounding the Impoundments is clearly shown. Figure 2 also depicts evidence of early dredging in the area north and west of the TCRA Site, shown by the linear cuts into the marsh with leading arcs at the limits of dredging into the shoreline. The arcs are indicative of a dredge “swing” as it advances into the shoreline to mine materials, and similar features can be observed in more recent aerial photographs of the area. Typical sand dredging operations are described in the attached Appendix B.

To further illustrate the magnitude of the dredging that has occurred in this area, Figure 8 (2002 conditions and recent bathymetry) has been provided in reduced size on Figure 9, shown adjacent to the 1966 aerial photograph (provided earlier as Figure 2), the latter depicting the original flat topography in the same area as the dredging activity. Comparison of the conditions adjacent to and west of the TCRA Site from these two photographs enables easy identification of the substantial effects of dredging activities in this area. It should be noted that the emergent marsh areas that were at or near sea level after construction of the TCRA Site Impoundments (as shown in the 1966 aerial photograph), are now up to 20 feet deep adjacent to the TCRA Site. This drastic and varied change in elevation can only be explained by the removal of materials by the dredging operations documented in the USACE permit files.

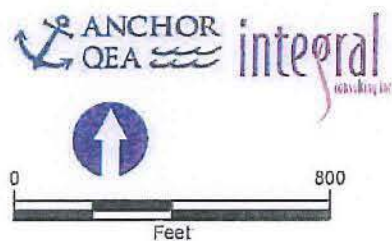
Figure 4
1998 Aerial Photo
Impact of Dredging on the San Jacinto Waste Pits TCRA Site
SJRWP Superfund/MIMC and IPC

- Figure 4, an aerial photograph taken in 1998, shows a breach in the edge of the northwestern berm of the TCRA Site, apparently caused by undermining in this area by dredging. This photograph also shows significant changes on the Big Star property and the shoreline of the eastern side of the Big Star property. Note the alluvial fan-like deposit along the eastern shoreline of the Big Star property, in what appears to be a newly formed mass of intertidal sediment. In addition, a plume of turbid water is emanating from the new sediment mass.

The aerial photographs show that by the time the 1998 aerial photograph (Anchor Report, Figure 4) was taken, a portion of the levee along the northwest portion of the Site waste impoundments had been knocked down. As discussed in the Anchor Report, bathymetric surveys of the northwest corner of the Site waste impoundments show that dredge line cuts through this area of the impoundments. Thus, it is clear that the dredging activities conducted by the Dredging Parties in the late 1990's pursuant to HIT Permit No. 19284 resulted in the undercutting and collapse of portions of the perimeter levee in this area of the impoundments.

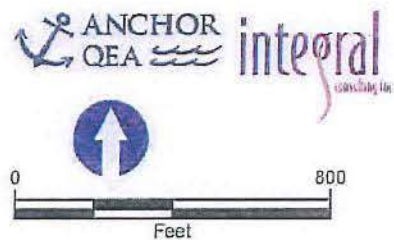
Figure 5
2002 Aerial Photo
Impact of Dredging on the San Jacinto Waste Pits TCRA Site
SJRWPF Superfund/MIMC and IPC

- Site conditions in the year 2002 are shown on Figure 5. In this photograph, the original berm failure observed in 1998 (Figure 4) is exacerbated to approximately twice the previous size. It is also important to note that a substantial amount of

newly deposited sediment is present along the shoreline of the TxDOT right-of-way between the Big Star property and the TCRA Site. Based on our review of the USACE files for the sand dredging permit in this area, it is our understanding that mitigation along this shoreline was required as part of the USACE permitting process to offset dredging impacts. Also, and more importantly, there are several prominent arced dredge cut shapes, from the Big Star property to the Impoundments, further indicating degradation of the berm in the northwestern part of the Impoundments by dredging. Finally, tidal flow lines along the northeastern side of the Impoundments clearly bend around the Impoundments and into the navigation channel under the bridge, indicating that a new preferential flow path has formed in this area of the Impoundments. There is further evidence of channeling in this area in later aerial photographs, and in recent bathymetric data discussed below.
